# **Galloway Glens Landscape Partnership**

## **Can You Dig It?**

Data Structure Report

1.2.g High Ground Wrecks and the Royal Observer Corps

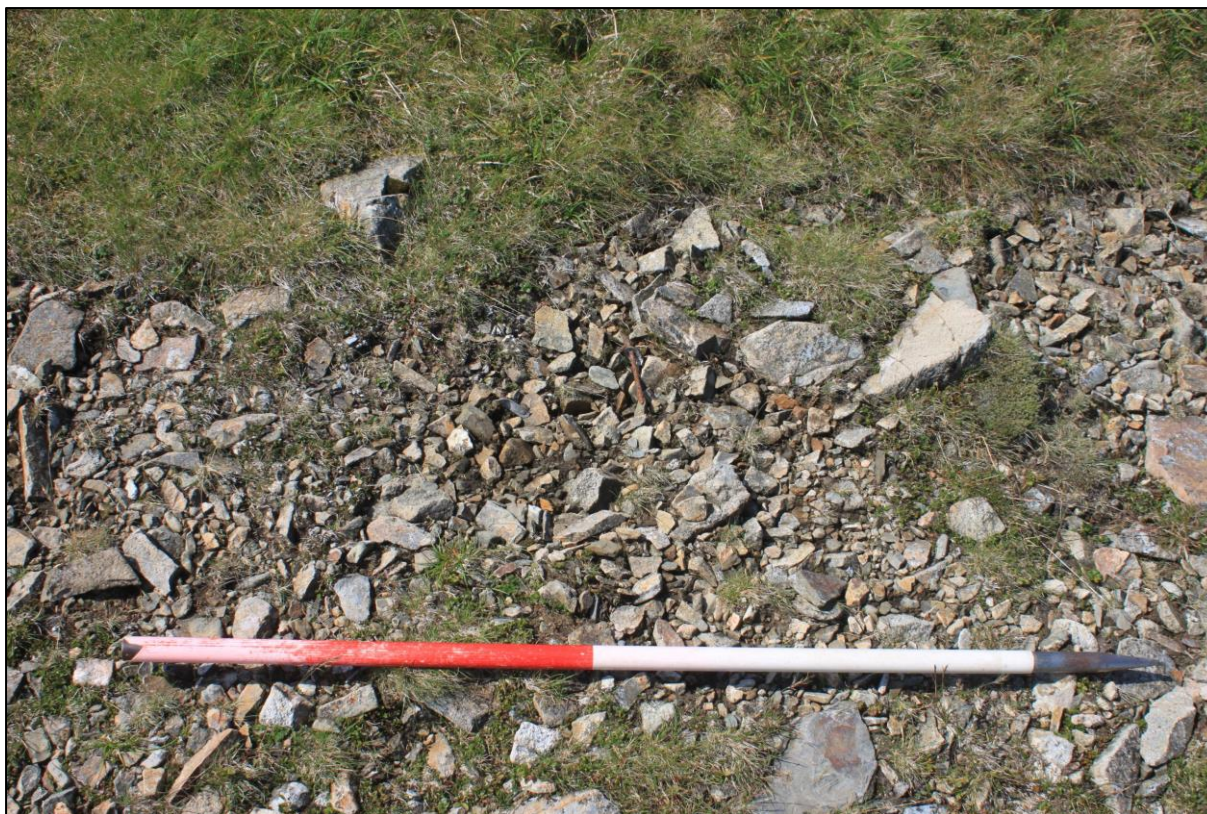
16. As with **S3**, the bedrock within each scar had been broken into smaller angular stones (Figure 3a). Several small metal fragments remained including pipes, screws, a possible tank, fuselage fragments and some timber fragments (Figure 3b).

Figure 3a: Detail of bedrock scars of **S4** from the south

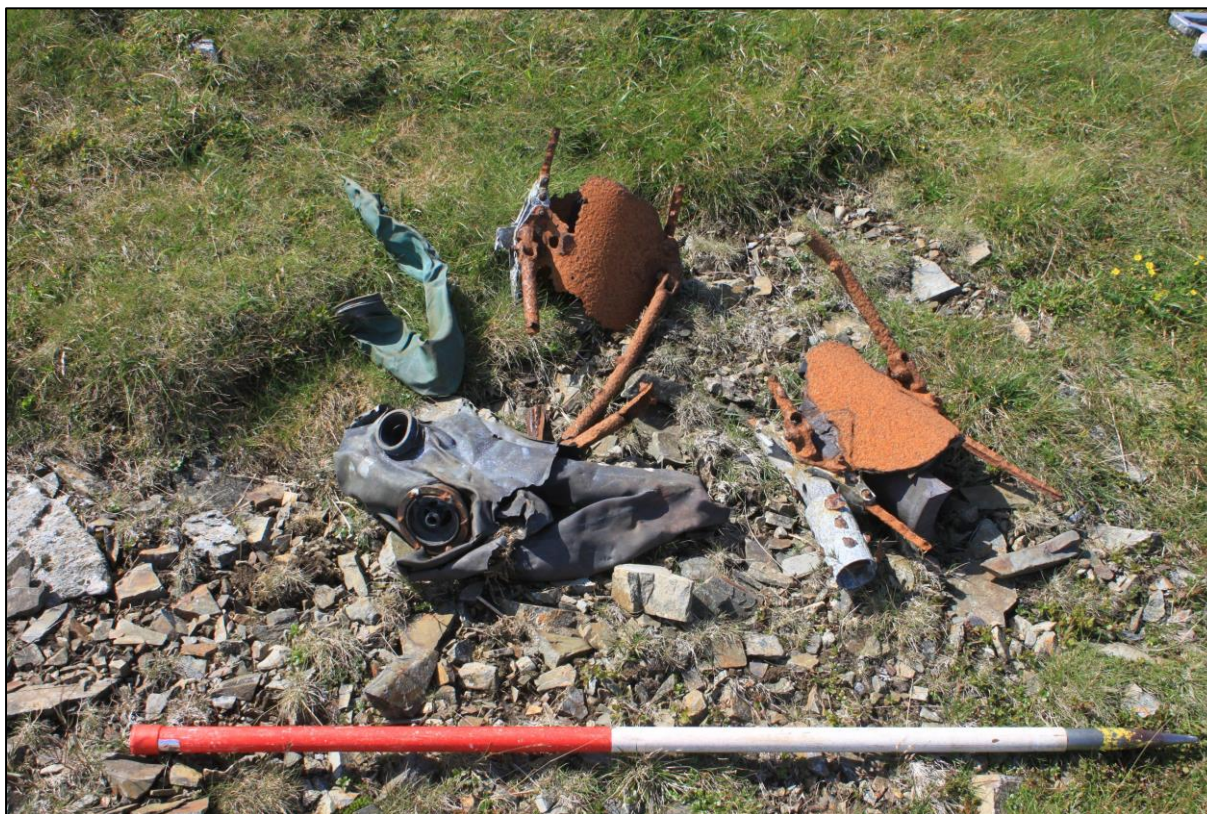
Figure 3b: Detail of wreckage of **S4** from the southeast
