# **Galloway Glens Landscape Partnership**

Data Structure Report

Woodhead Lead Mine, Carsphairn

by Claire Williamson  
issued 25<sup>th</sup> August 2023

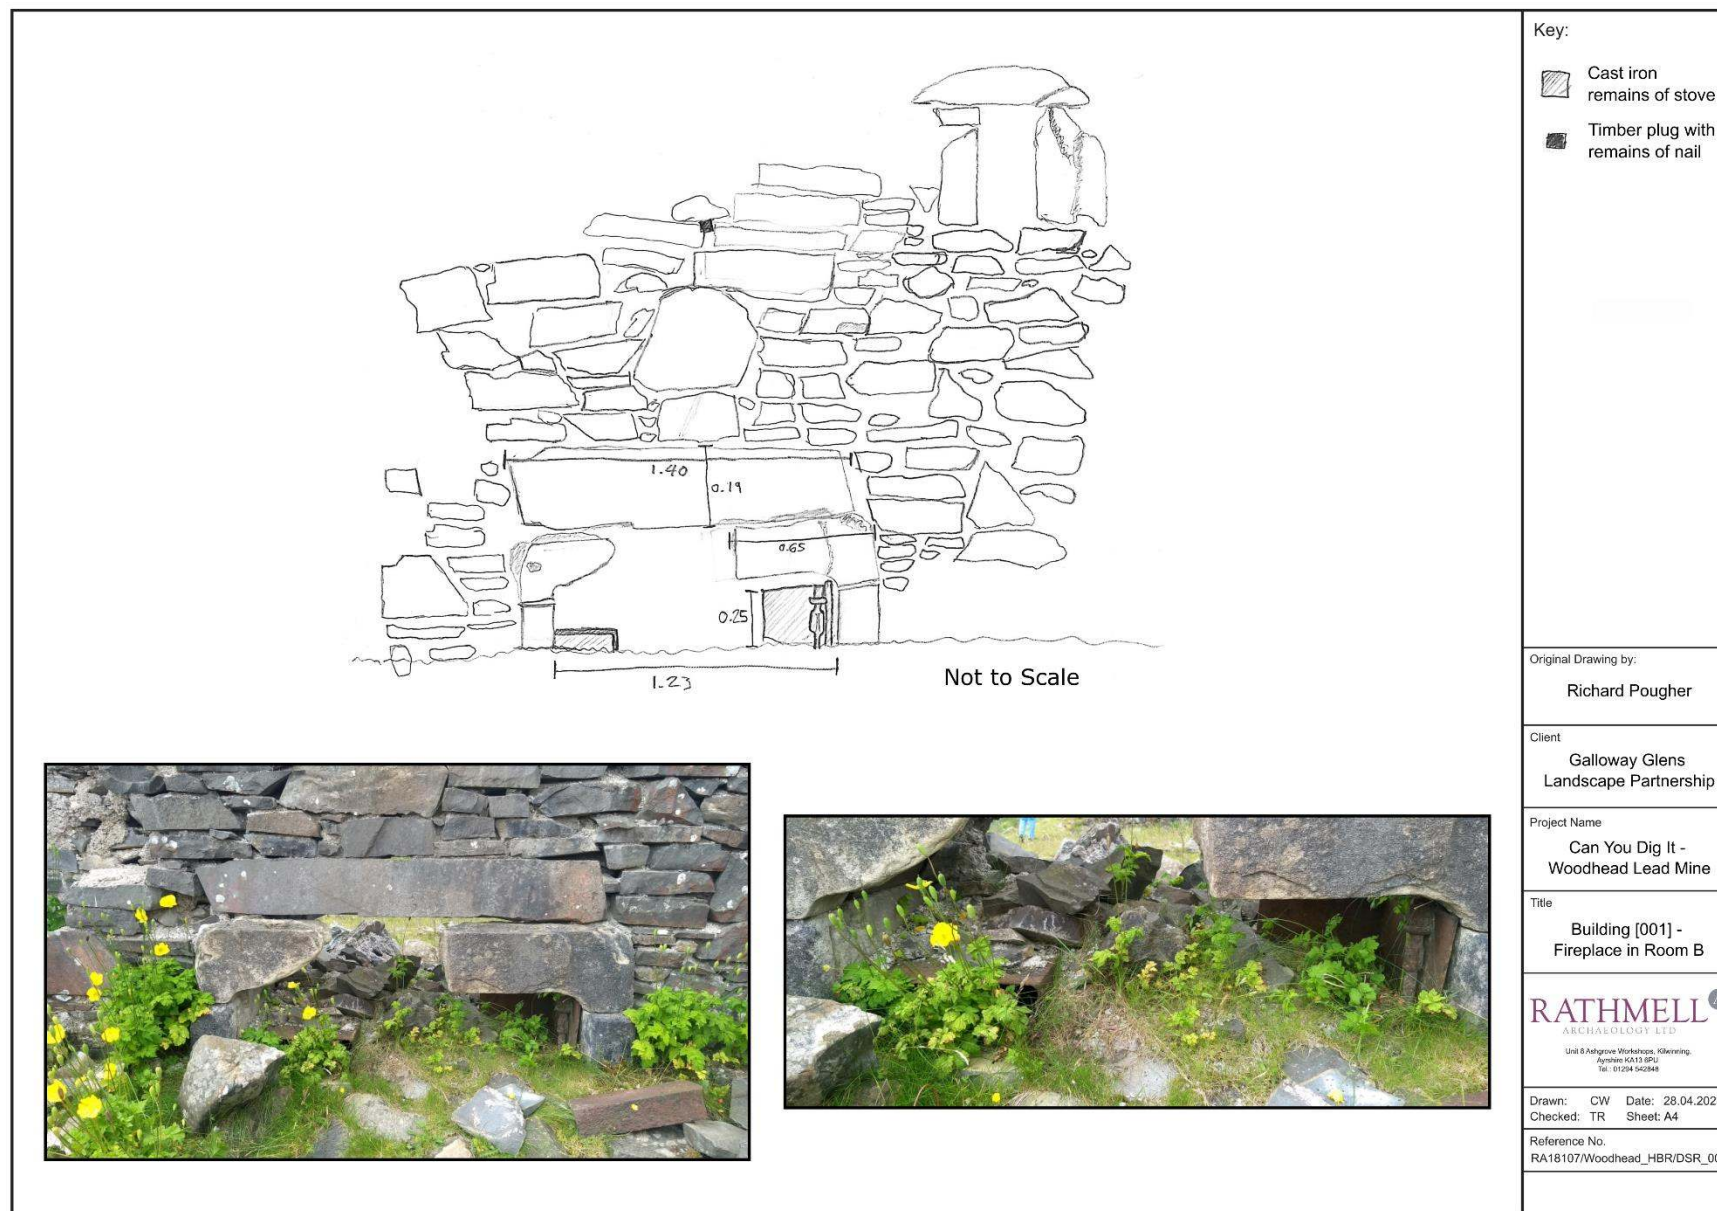
27. At the centre of the southwest wall sits a substantial fireplace, which measures 1.25m wide and 0.55m deep (see Figure 6). Only the upper portion of the fireplace remains visible as its interior is partially infilled by tumble. It is capped by a large, shaped blonde sandstone block (its central section now missing) with a further greywacke lintel above. The vertical jambs are also shaped blonde sandstone, and the top of a cast-iron stove, with possible oven and hot plate, is visible within the rubble infill of the interior.

Figure 6: Fireplace in the southwest wall of Room B, Building [001]

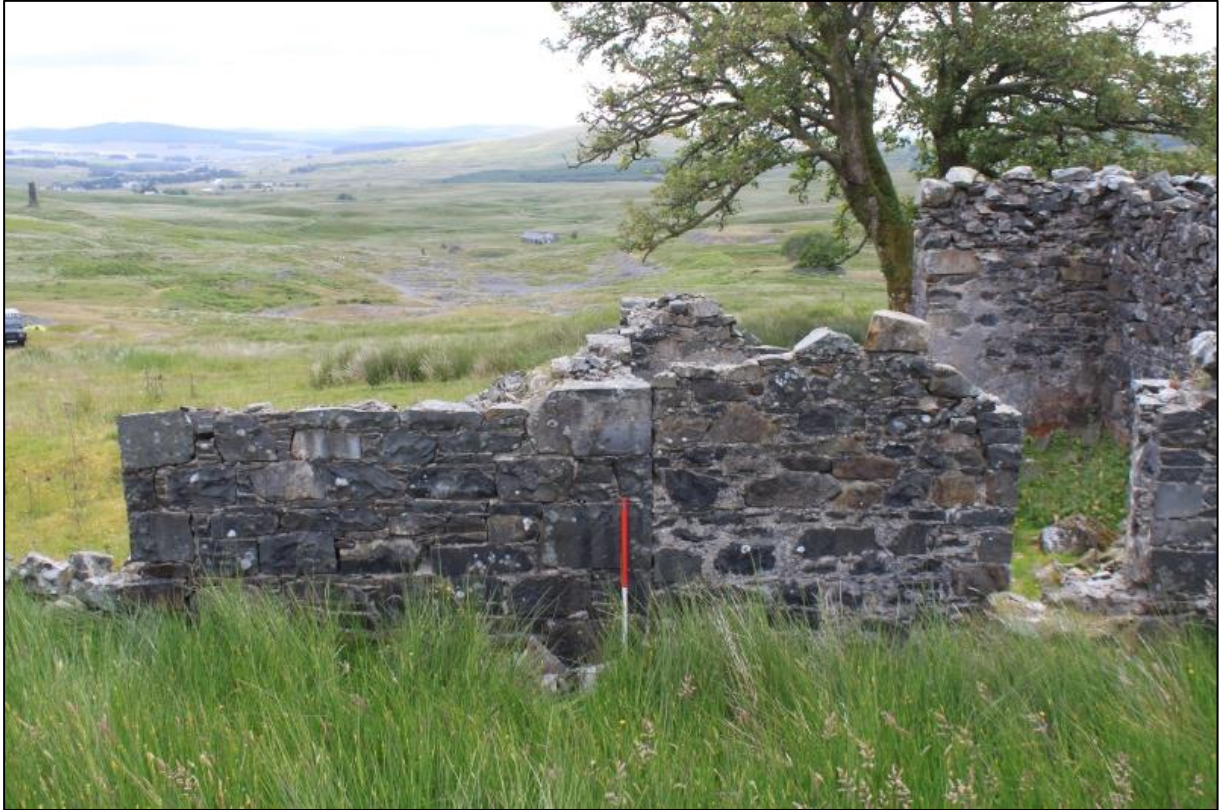
Figure 7a: External NW facing elevation of Building [001] showing junction between Rooms D and E

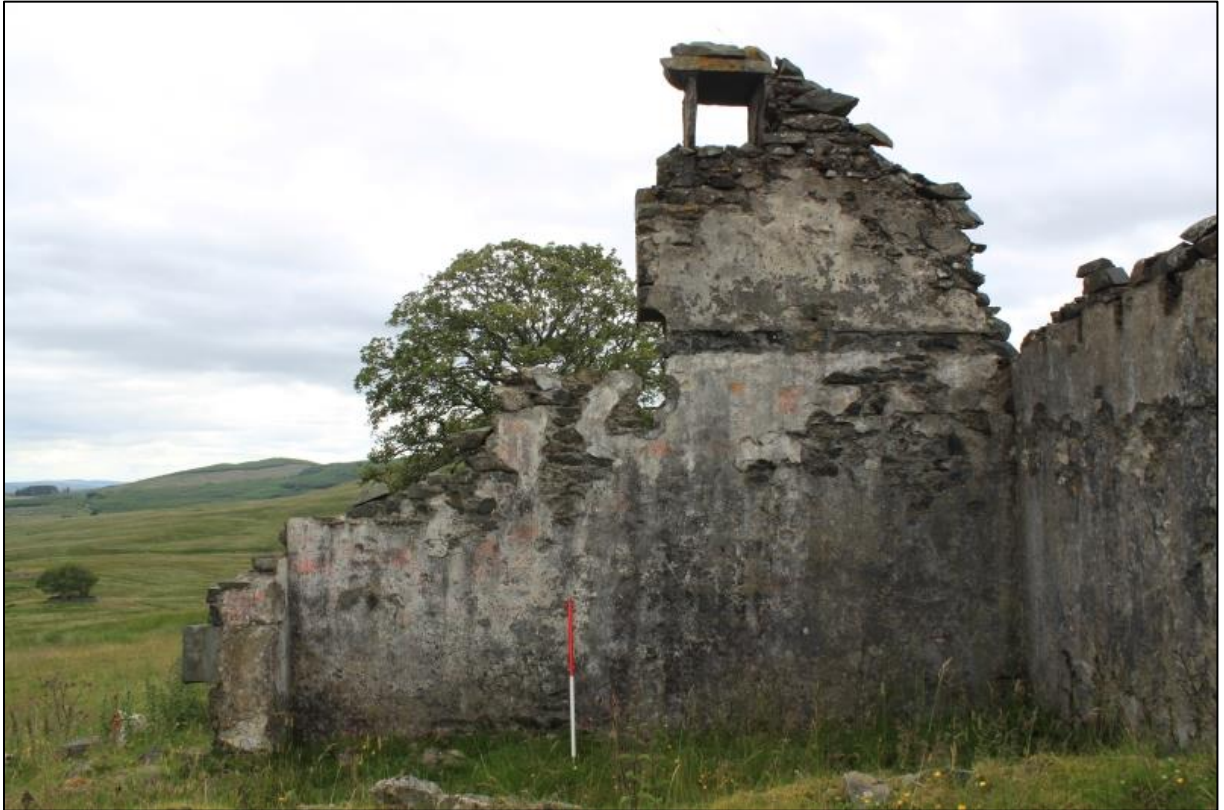
Figure 10a: Building [003] – south wall of Room A

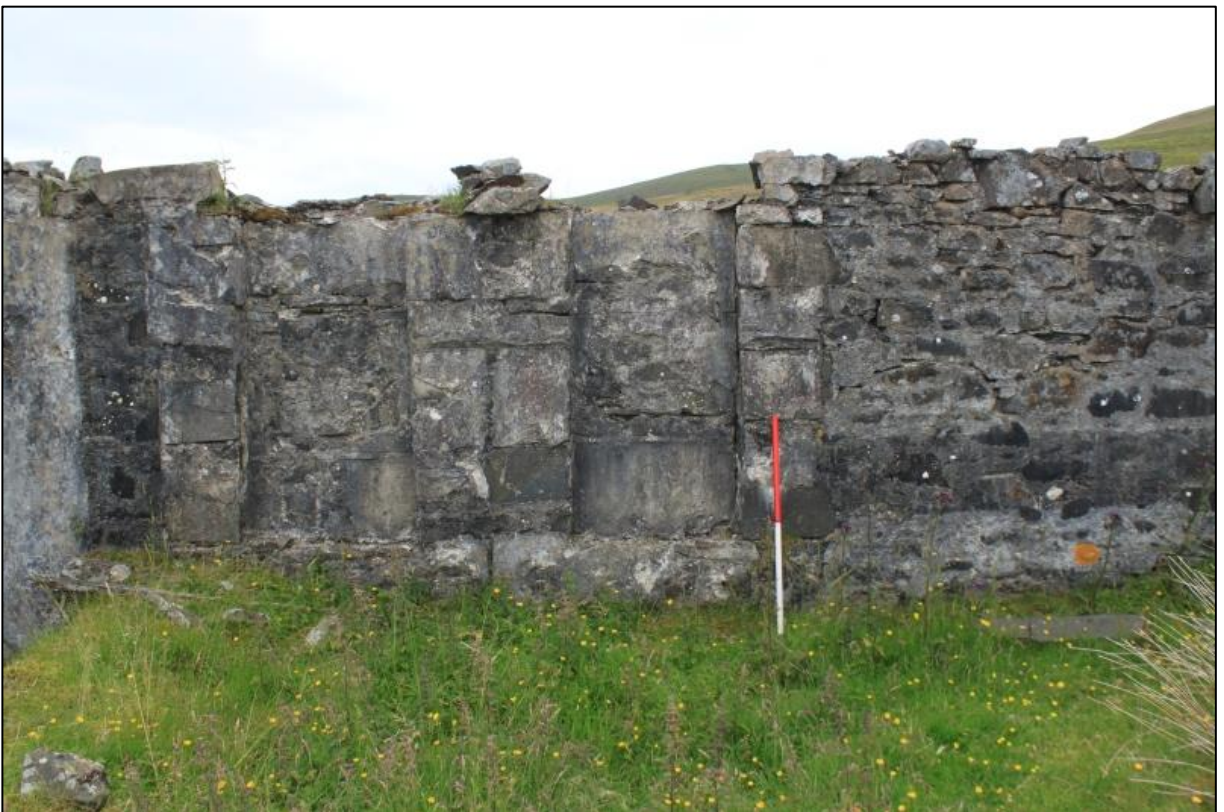
Figure 10b: Building [003] – blocked windows at the south end of the west wall of Room B

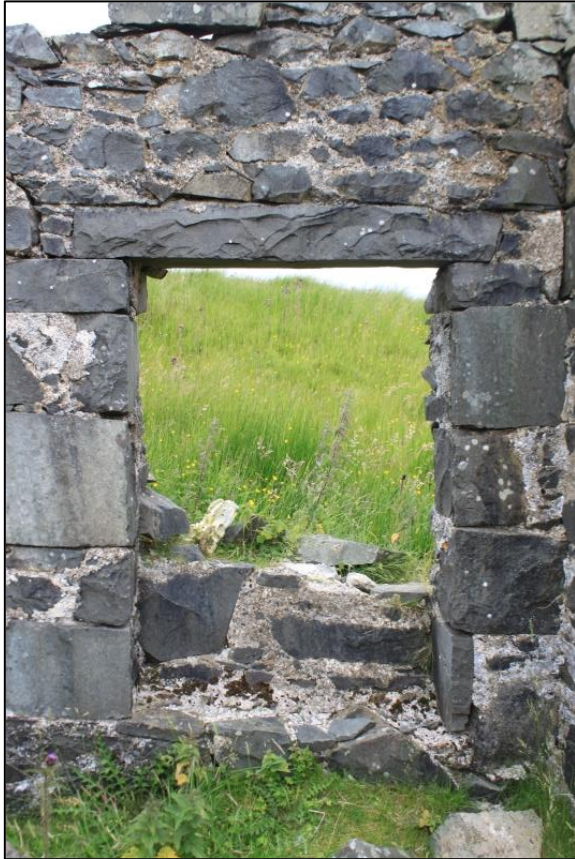
67. A fifth window sits at the eastern end of the north wall (Figure 11a). It measures 0.93m wide by 1.4m tall and sits 0.15m up from the internal ground level. Its lintel and jambs are formed by large, squared greywacke blocks but its sill appears to be missing. The lower 0.4m of the opening has been blocked with coursed rubble containing traces of lime plaster.

Figure 11a: Building [003] - partially blocked window in N wall of Room B

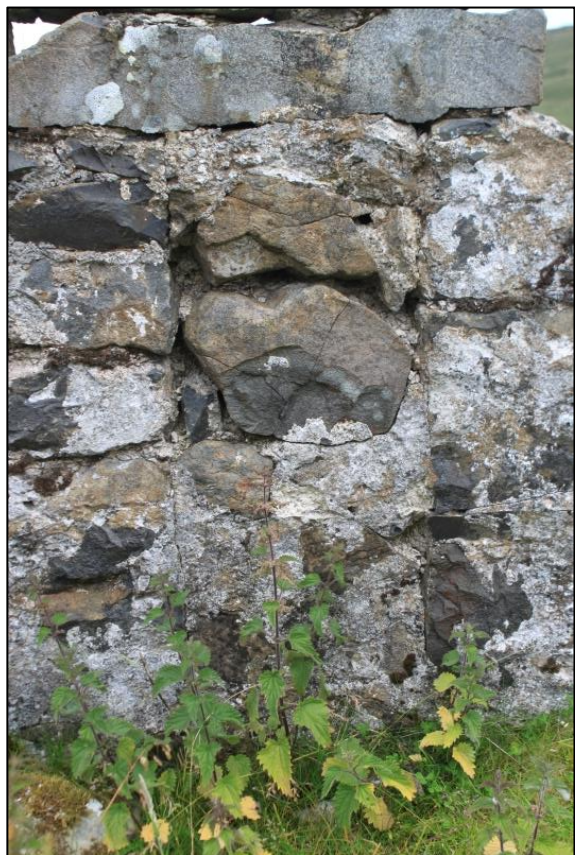
Figure 11b: Building [004] – blocked opening in SE wall

73. The only other features noted in the surviving walls are two narrow, blocked openings that sit at ground level, one in each of the southwest and southeast walls. Each opening measures around 0.33m wide and 0.95 high. The southeast example is still capped by a stone lintel (Figure 11b). Both have been infilled with rubble and mortar. There might also be a similar opening in the northwest wall, but this wall has mostly collapsed making it unclear.

141. At the base of at least two of the walls, there is evidence of narrow vertical openings which were later blocked. It is possible that these were vents relating to the proper storage of the powder, which needed to be kept dry. Vents positioned near the base of the walls can be seen in the newer square magazine found at Glencrief (see weblink for *Mine Explorer* in References). By the time of the 1895 Ordnance Survey 25-inch map (Figure 1b), however, Building [004] was in use as a 'Kennel' and the low-level openings were likely blocked for this purpose.

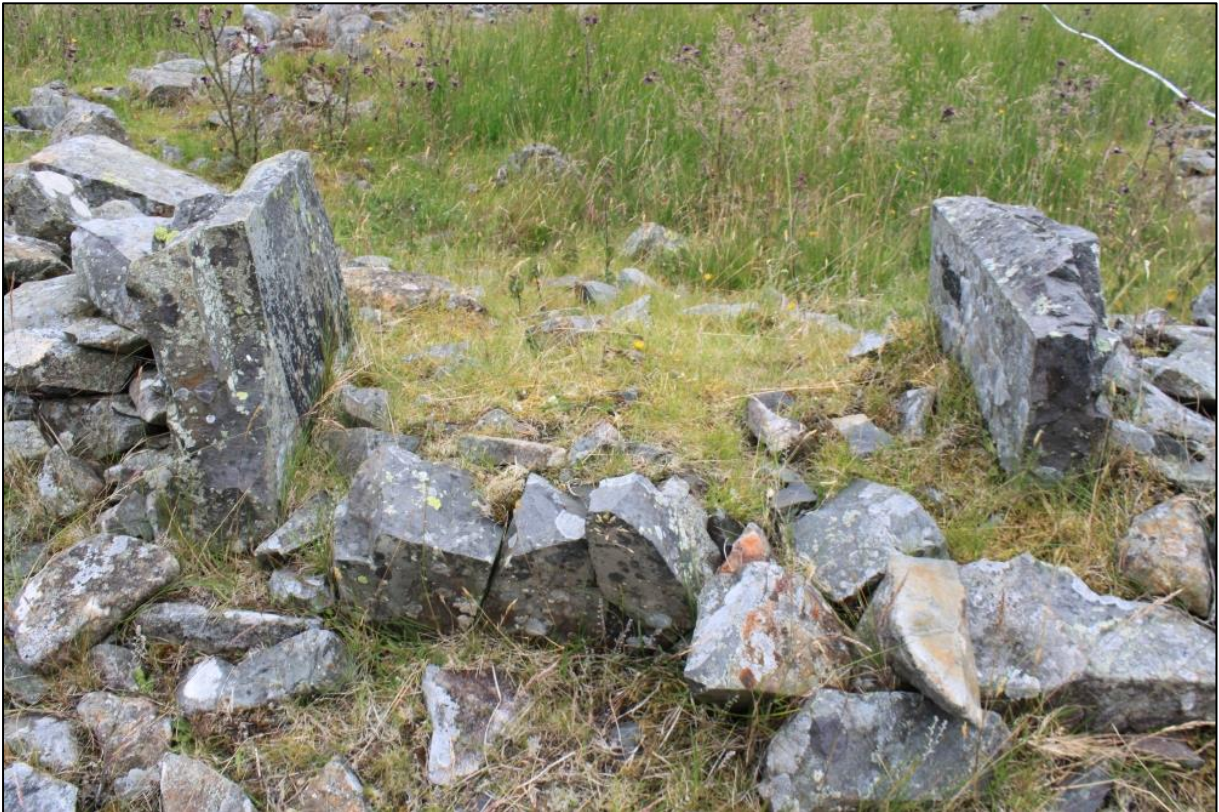
Figure 14a: Building [005] – possible jambs of fireplace in NE wall of Room C, taken from the SW

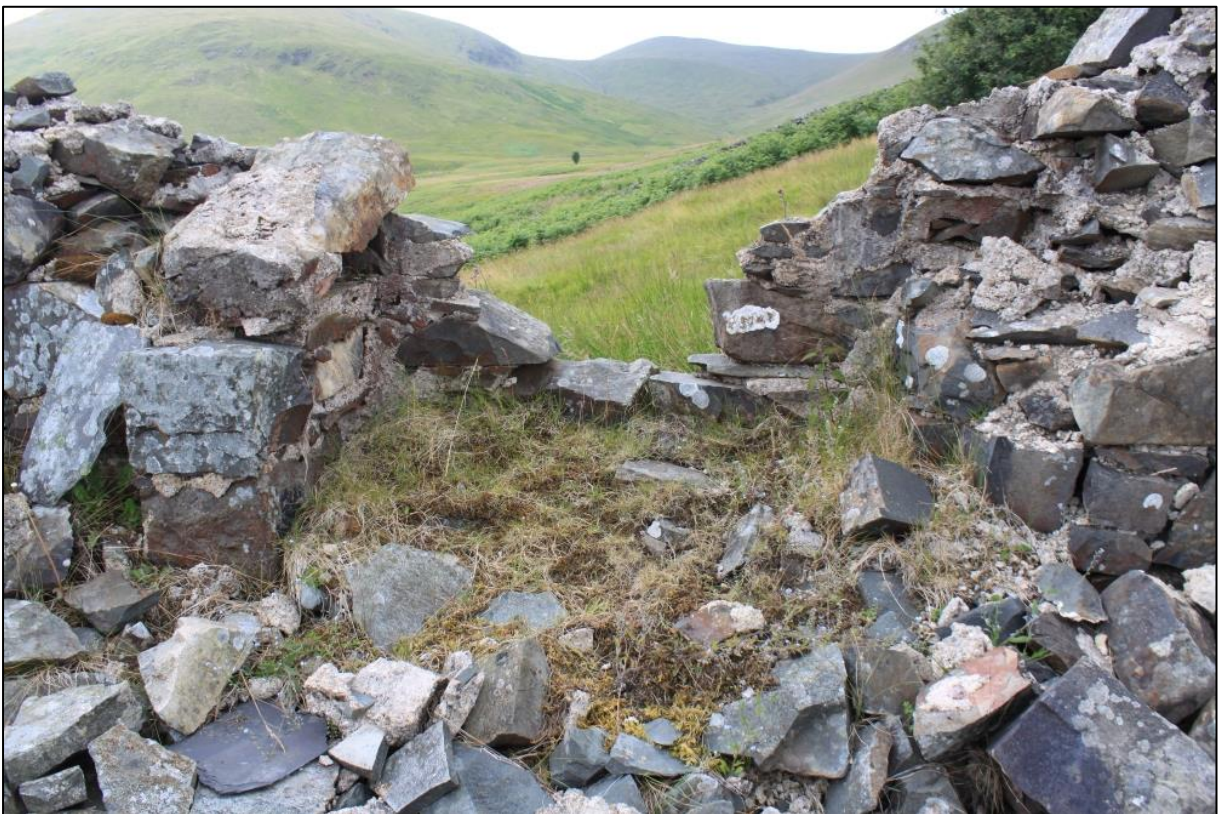
Figure 14b: Building [005] – remains of a possible fireplace in the SW wall of Room A, taken from the NE

79. Traces indicating the locations of fireplaces can be seen in each of the internal subdividing walls, as well as in either gable end. Most only survive as one or two vertically placed stones, visible within the base of the walls, suggesting the site of jambs (see Figure 14a). In the gable wall, which formed the southwest wall of Room A, the site of a fireplace is more strongly indicated by the lower remains of a recess measuring 1.05m wide (Figure 14b).

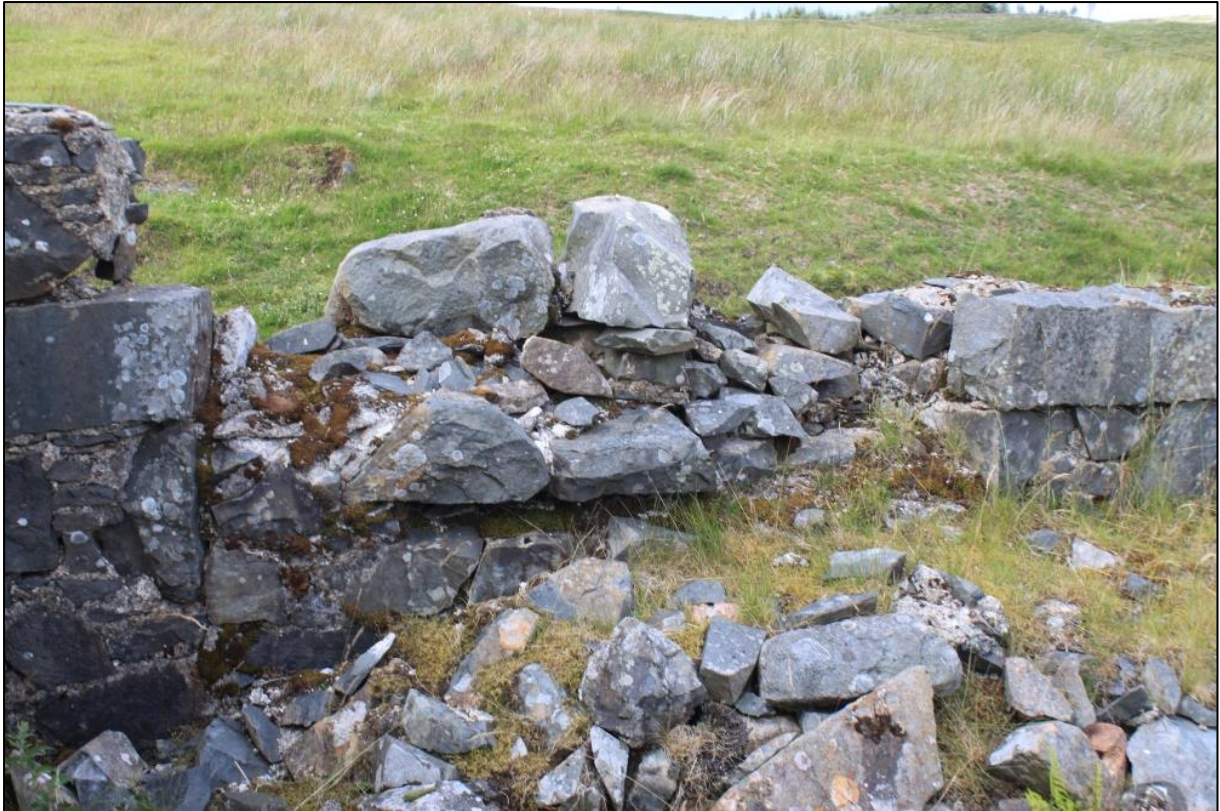
Figure 17a: Building [007] - blocked opening within NW wall of Room B, internal view

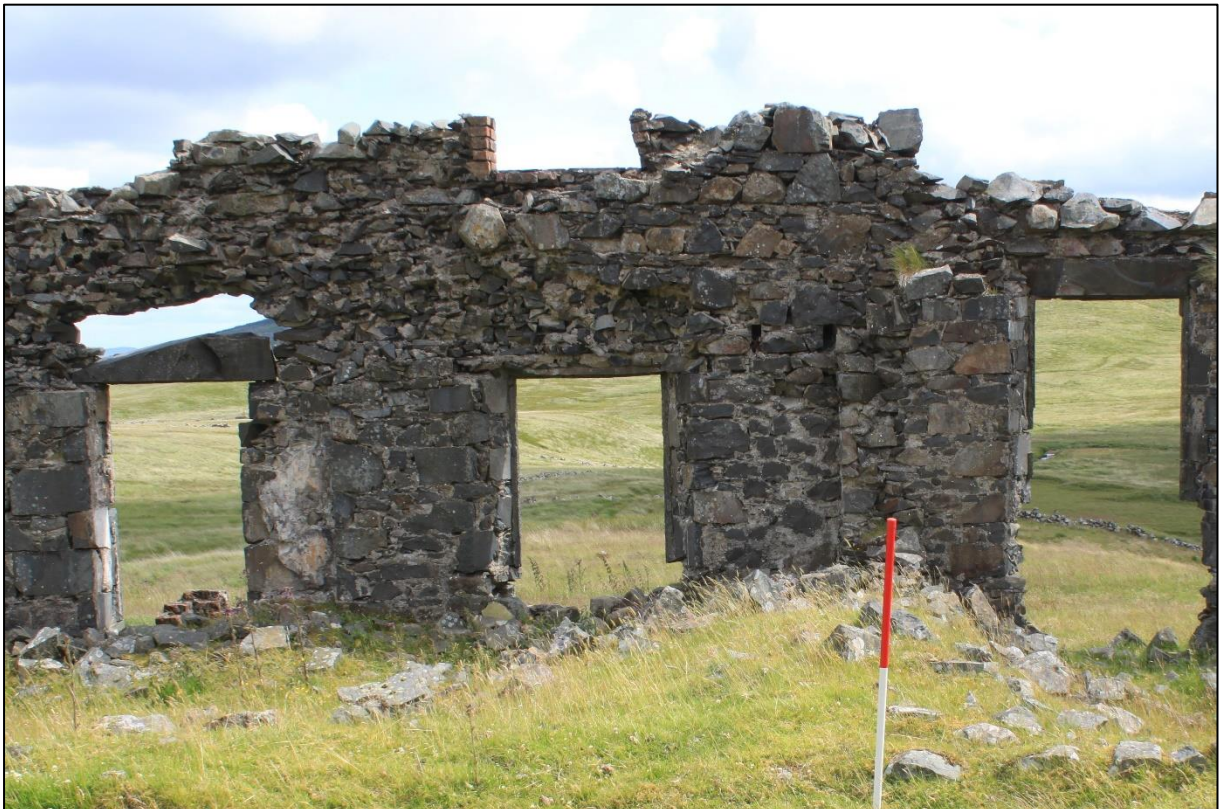
109. At first-floor level, directly above the southwest window, the lower courses of a possible third window are visible (Figure 17b). What may be the sill and lower jambs of this window are formed by red brick, in contrast to the other openings, which indicates that it is a later addition or modification/repair of an earlier opening. It could not be reached for measurement but appears to be similar in width to the ground-floor windows.

Figure 17b: Building [007] – Internal view of SW wall of Room D showing joist holes and brick traces around possible first-floor window

153. Another potential first-floor window can be identified by the line of bricks that sits at the southwest end of Room D. These bricks have likely been inserted during a later modification or repair, and it is interesting to see there are no first-floor windows in the southwest wall of the building in Figure 22a. This photograph was taken in 1886 after the schoolhouse had been converted into a shooting lodge, and the brick might represent a window that had been blocked before or during its conversion. Further to this, looking at the school in the background of Figure 20b, there may be two dormer windows present on the school's front façade; if this is the case, then perhaps these were removed at some point and replaced with the skylights seen in the later image (Figure 22a). This is a very tentative suggestion, however.

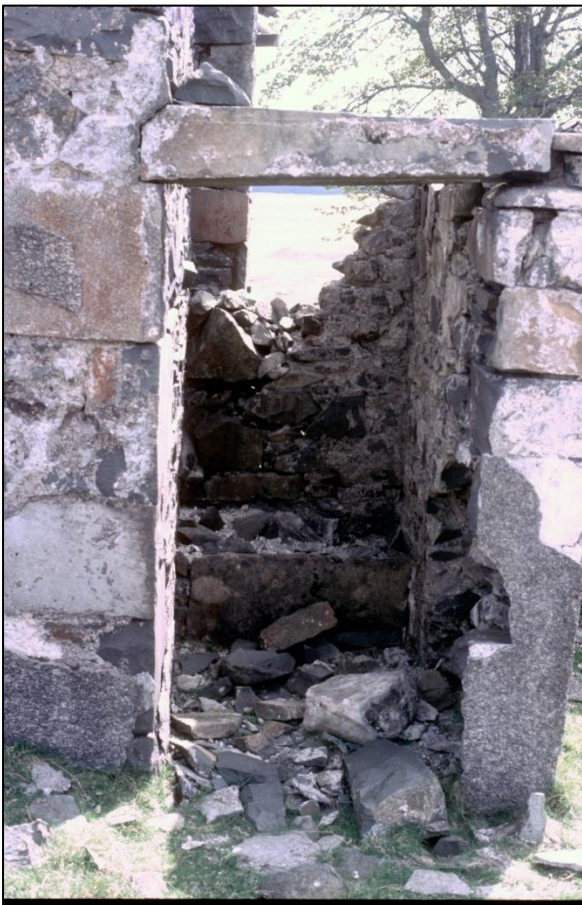
Figure 19b: Building [001] – external view of doorway in NW wall of Room A taken in 1987, courtesy of Anna Campbell
