# **Galloway Glens Landscape Partnership**

## **Can You Dig It?**

Data Structure Report

1.2.g High Ground Wrecks and the Royal Observer Corps

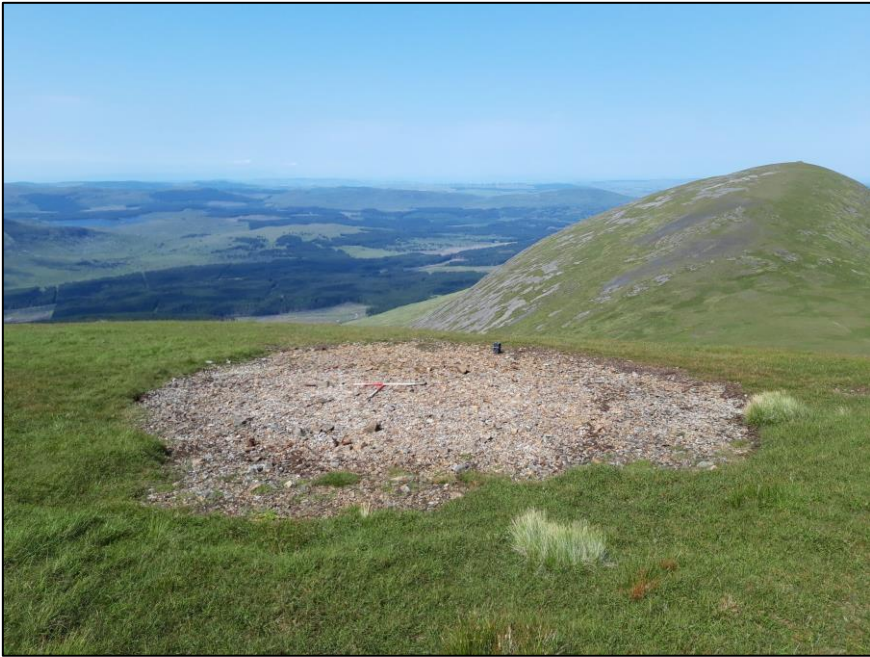
13. The site of the crash at **S3** remained visible as a sub-circular area of exposed bedrock (Figure 2a) measuring 8.8m east to west by 10.8m transversely. The exposed bedrock had been broken into small grey angular stones, which had an average size of 0.1m by 0.15m. The area also contained many fragments of charred aluminium, mostly pipes. A mainly intact battery was located at the northwest corner of the area (Figure 2b).

| No | Site | HER Ref: | Description | NGR | Image from Site Inspection |
|---|---|---|---|---|---|
| S3 | Crash Site: Avro Anson Mk.I | -<br>MDG13043 | <p><b><u>Research Design</u></b></p> <p>Documentary sources record that the site was cleared of all large wreckage following the crash. The site was recorded by the Peak District Air Accident Research Group. They reported that the site was visible as a burnt-out scar with small pieces of wreckage.</p> <p><b><u>Walkover Survey</u></b></p> <p>Wreck 3 was located as a sub-circular area of exposed bedrock measuring 8.8m east-west by 10.8m transversely. The exposed bedrock had an average size of 0.1m by 0.15m was grey in colour. It was broken into angular pieces. The area also contained many sections of aluminium, mainly as pipes. A battery was located at the northwest corner.</p> | NX 49695, 87180 | |

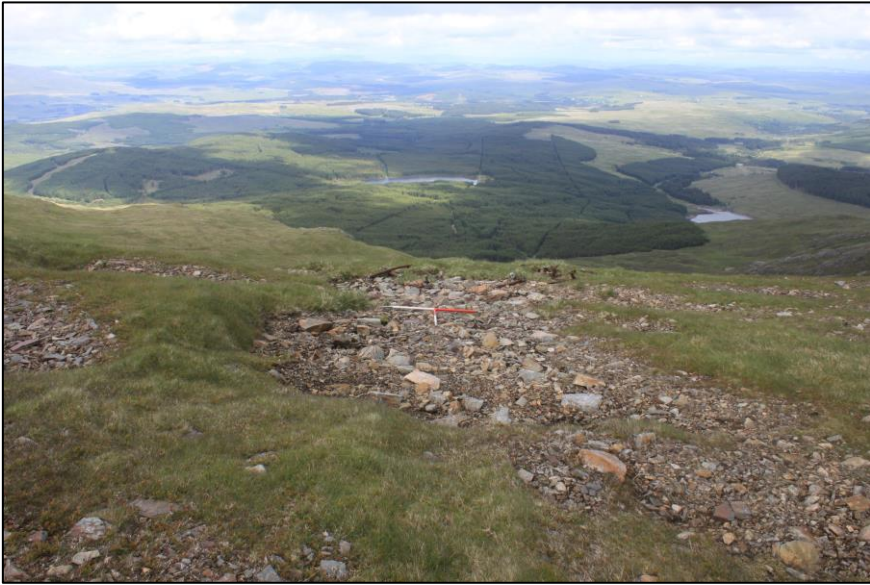
16. As with **S3**, the bedrock within each scar had been broken into smaller angular stones (Figure 3a). Several small metal fragments remained including pipes, screws, a possible tank, fuselage fragments and some timber fragments (Figure 3b).

| No | Site | HER Ref: | Description | NGR | Image from Site Inspection |
|---|---|---|---|---|---|
| S4 | Crash Site: de Havilland Mosquito N.F. Mk.II | -<br>MDG13046 | <p><b><u>Research Design</u></b></p> <p>The site was visited by the Peak District Air Accident Research Group. They reported a scar at crash site with small fragments remains. Some larger remains of undercarriage were visible slightly downhill. Mosquito planes had a wooden frame, the bulk of the plane would have been destroyed on impact.</p> <p><b><u>Walkover Survey</u></b></p> <p>The wreck was located as a wide spread of bedrock “scars” over the hillside just under the lip of the hill at the “scar of folk”. Nine scars containing airplane debris were located, in addition to a number of small scars without material. The largest scar measured 7.6m by 11.8m and contained the fuselage and gears as well as metal and timber fragments. The other scars containing metal and timber fragments had an average size of between 2m x 0.5m and 3m x 1m. The scars were all sub-circular in form.</p> | NX 50474, 87032 | |

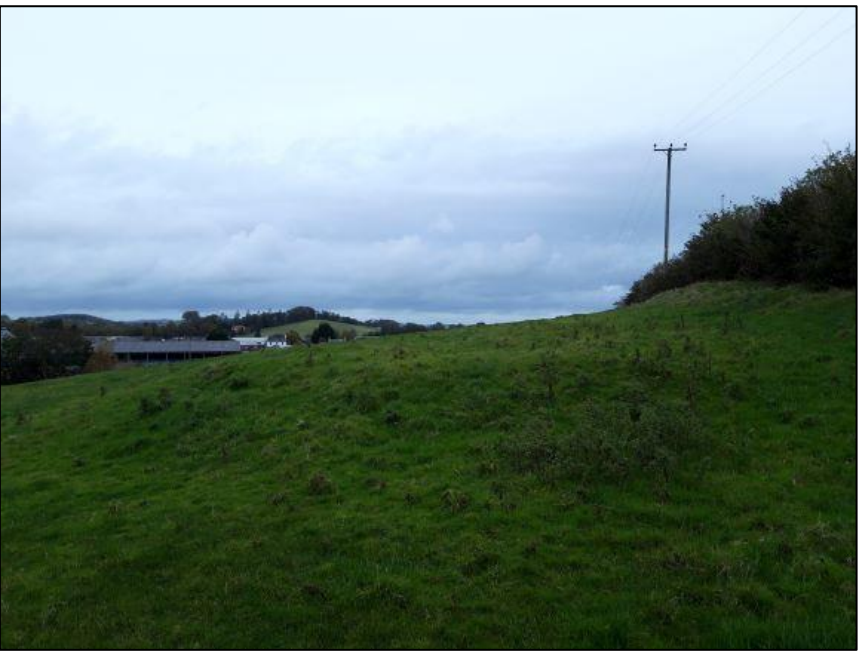
| <b>S6</b> | Castle Douglas<br>ROC Post<br>33/C.1;<br>24/D.2; 22/E.3<br><br>WW2 post;<br>Underground Post | -<br>- | <p><b><u>Research Design</u></b></p> <p>Opened August 1940. Equipped with flares to warn aircraft of high ground (Granite) in 1943. Later added an underground nuclear post in December 1961. Post closed in 1991. Underground post was probably demolished in 1991.</p> <p><b><u>Site Visit</u></b></p> <p>Underground post has been completely removed. Some faint traces of the disturbance from its demolition remain as an earthwork.</p> | <p><b>Underground post (site of):</b><br/>NX 76804, 62300</p> | |

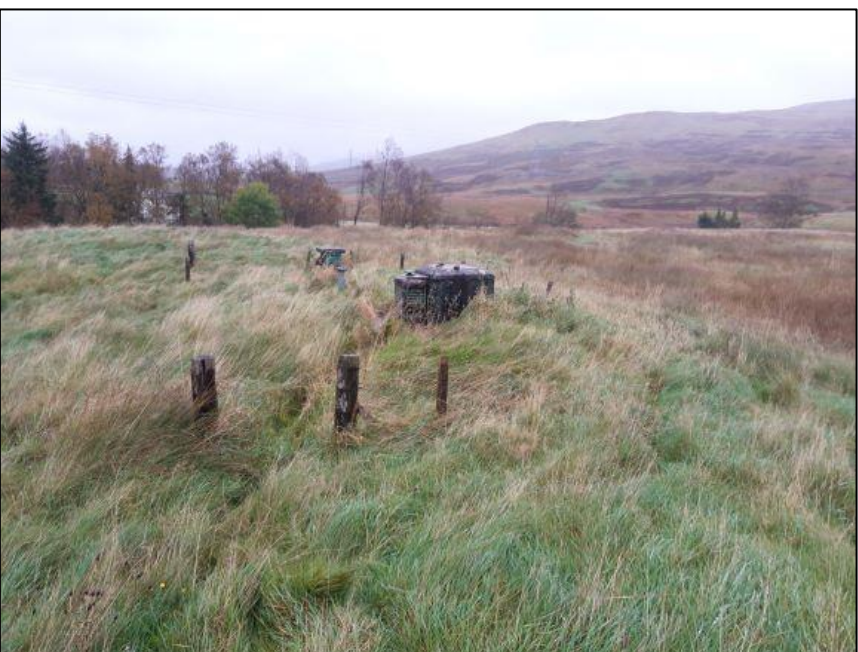
| <b>S7</b> | Carsphairn<br>ROC Post<br>33/K.2; 25/H.2;<br>22/A.1<br><br>WW2 post,<br>Underground Post | -<br>- | <p><b><u>Research Design</u></b></p> <p>Opened in August 1940. Nuclear bunker added in January 1962. Probably disbanded in 1991. Possible remains of WW2 post visible on low hill. Underground bunker visible within compound.</p> <p><b><u>Site Visit</u></b></p> <p>Surface remains of underground post still present and intact including ventilation shaft, access hatch and sampling/fixd survey meter probe – all made from concrete. Enclosing fence line still present. No access to interior of post as metal access hatch is padlocked. A circular black cover has been fitted to the side of the air vent which sits on its own.</p> | <p><b>Underground Post:</b><br/>NX 56089, 93347</p> | |

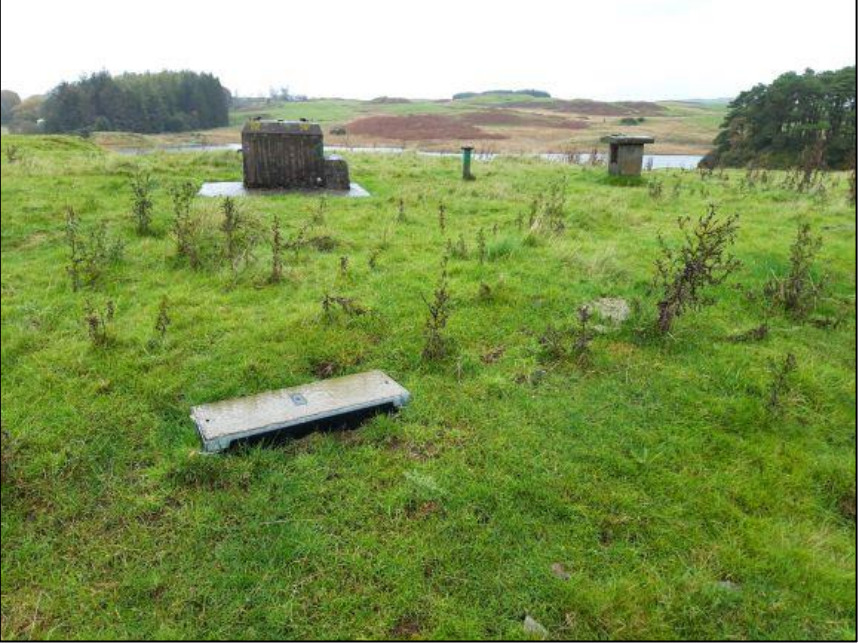
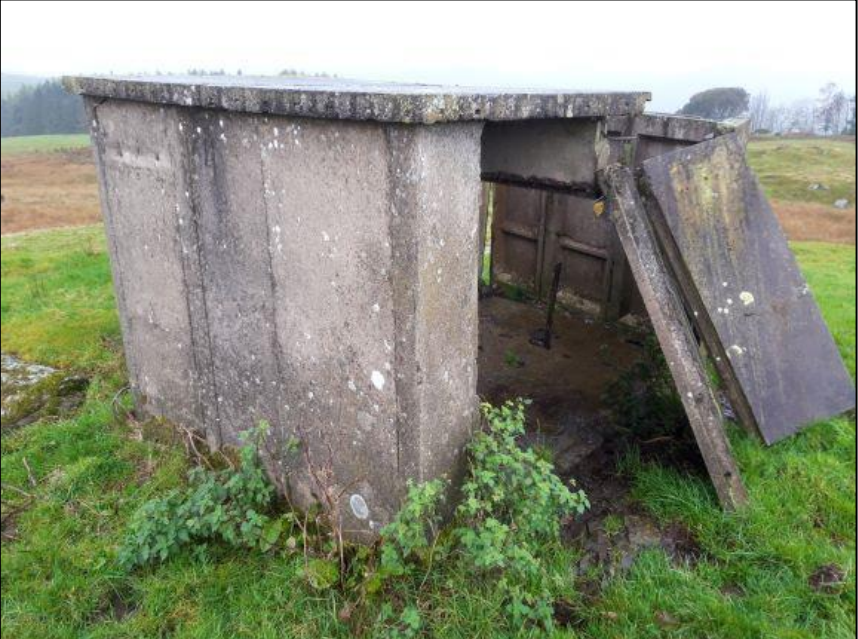
| S8 | Dalry<br>ROC Post<br>33/B.1; 25/C.2;<br>22/A.2<br><br>WW2 post,<br>Orlit A,<br>Underground<br>Post | -<br><br>- | <p><b><u>Research Design</u></b></p> <p>Opened in September 1940. Underground nuclear post added in January 1964. Probably disbanded in 1991. Orlit A and underground bunker still visible.</p> <p><b><u>Site Visit</u></b></p> <p>Surface remains of underground post still present including ventilation shaft, access hatch and sampling/fixed survey meter probe – all made from concrete. Phoneline running into the post's location also still present. Remains are all still intact apart from missing louveres on the air vents. No access to interior of bunker as metal access hatch is padlocked.</p> <p>Remains of Orlit Type A structure still standing. A small rectangular structure only single storey, it has a concrete floor with all walls made of reinforced concrete. It is divided into two halves – one side is unroofed with the remains of two concrete struts projecting from the floor. The other half is roofed with a flat concrete roof. The only internal feature remaining in this half is a wooden bench along the rear wall. There is only one doorway from the exterior leading into the roofed section, and a single internal doorway leading into the unroofed section. The structure is mostly intact apart from the front wall which has been separated from the structure and left leaning against it.</p> | <p><b>Underground Post:</b><br/>NX 63249, 81400</p> <p><b>Orlit Type A:</b><br/>NX 63033, 82001</p> | <p><b>Underground Post:</b></p> <p><b>Orlit Type A:</b></p> |

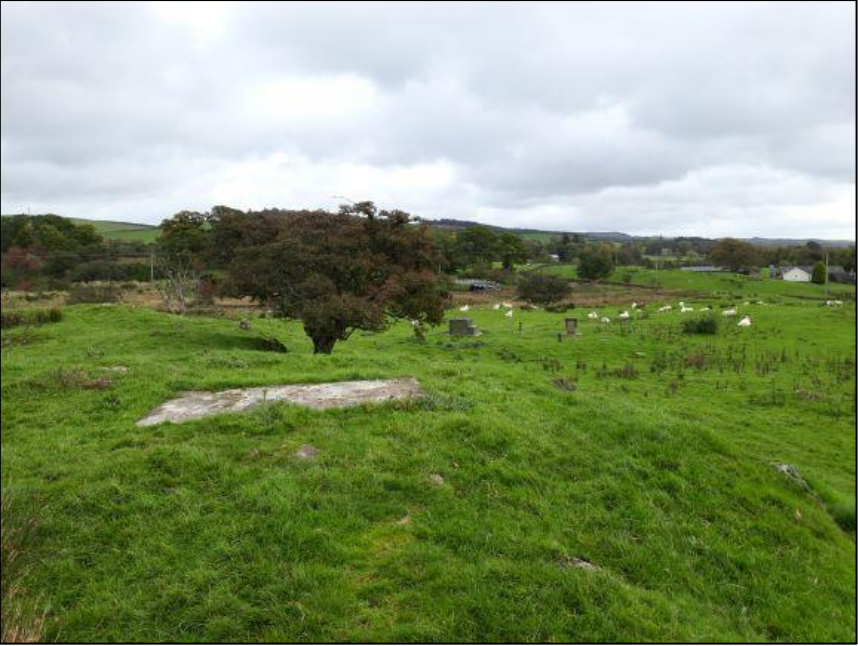
| S9 | Parton<br>ROC Post<br>33/B.3; 25/C.4;<br>22/A.3;<br><br>WW2 post,<br>Nuclear<br>Bunker | -<br><br>MDG25531 | <p><b>Research Design</b></p> <p>Opened October 1940. Equipped with “granite” 1943. Augmented “granite” 1944. Nuclear post established April 1960. Post probably disbanded in 1991. Concrete base of Orlit A visible on low hill near bunker.</p> <p><b>Site Visit</b></p> <p>Concrete base of Orlit Type A still present but nothing else remains.</p> <p>Surface remains of underground post still present and intact including air vent, access hatch and sampling/fixed survey meter probe – all made from concrete. The louvres on the ventilation shaft are still intact. No access to interior of post as metal access hatch is padlocked. A short, narrow upright pipe is visible protruding from the ground near to the meter probe is possibly the remains of a Bomb Power Indicator baffle plate.</p> | <p><b>Underground Post:</b></p> <p>NX 68854, 70358</p><br><p><b>Orlit Type A:</b></p> <p>NX 68836, 70365</p> | <p><b>Underground Post:</b></p> <br><p><b>Orlit Type A:</b></p> |

62. The condition of the surface features appears to be particularly good at **S9** with the concrete appearing mostly intact and a large portion of the green paint still visible.
